# Studying the tensile behaviour of compacted Hollin Hill clay

Yu-Jun Cui

Ecole des Ponts ParisTech

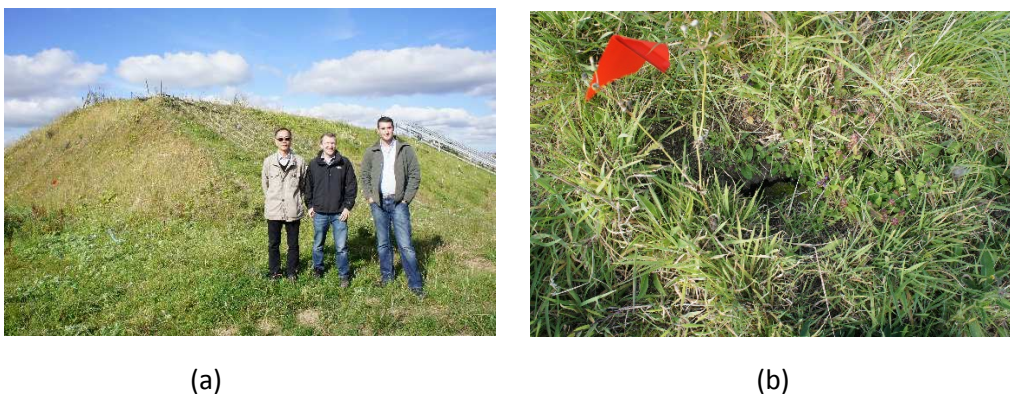
Figure 1b shows one of the cracks identified in the southern slope of the embankment. Although the origin of the cracks are still in discussion, it is generally admitted that for given soil, when the internal extension stress mainly due to the suction gradient over depth is higher than the soil tensile strength, cracks occur. This explains why the topic of soil cracking has been attracting more and more interests.

Figure 1. Bionicle experimental embankment. (a) An overall view with my friends Dr Hugues (middle) and Dr Stirling (right); (b) one of the identified cracks

An experimental embankment was constructed during the Bionicle project (see Figure 1a). Different measurements have been done since then, including soil resistivity, moisture water content, suction, soil temperature, soil cracks' geometry, etc. It is worth noting that two weather stations were installed, one on the crest and another on the northern side of the embankment, allowing the comparison of the effect of micro-climate on the embankment behaviour. Note also that an interesting discussion was organised during my stay with people working in the field of geography to see the possibility of the embankment geometry (and more) monitoring using laser scanner.

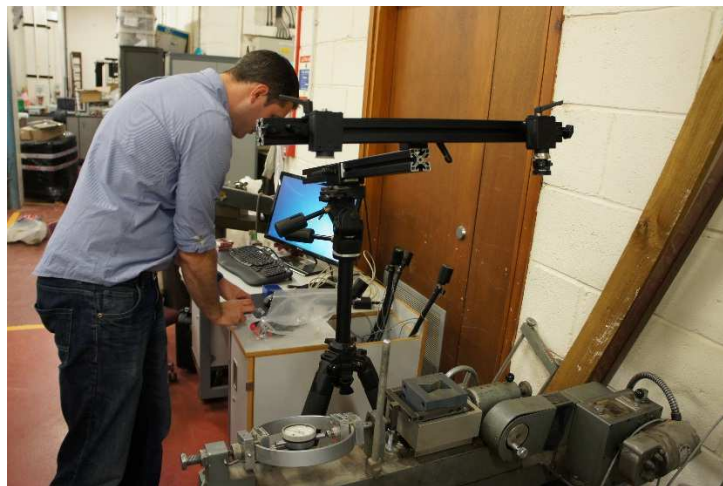
The laboratory is equipped with a digital image correlation system that allows the analyse of strain distribution of a tested sample. This system was successfully used in the PhD work of Dr Stirling (2014). It was planned to use this system for analyzing the behaviour of Hollin Hill clay under traction. Figure 2 shows the preparation of the DIC system by Dr Stirling. This image test was not performed finally because of a technique problem that needs more time to be solved.

Figure 2. Preparation of the digital image correlation (DIC) system by Dr Stirling

As far as the tensile testing is concerned, a standard direct shear machine was used. The shear box was modified so that a soil sample is pulled with one part fixed (left part in Figure 2) and another part pushed away (right part in Figure 2). During the test, the tensile force was monitored using a loading cell and the horizontal displacement was monitored using a comparator. More details can be found in the PhD dissertation of Stirling (2014).

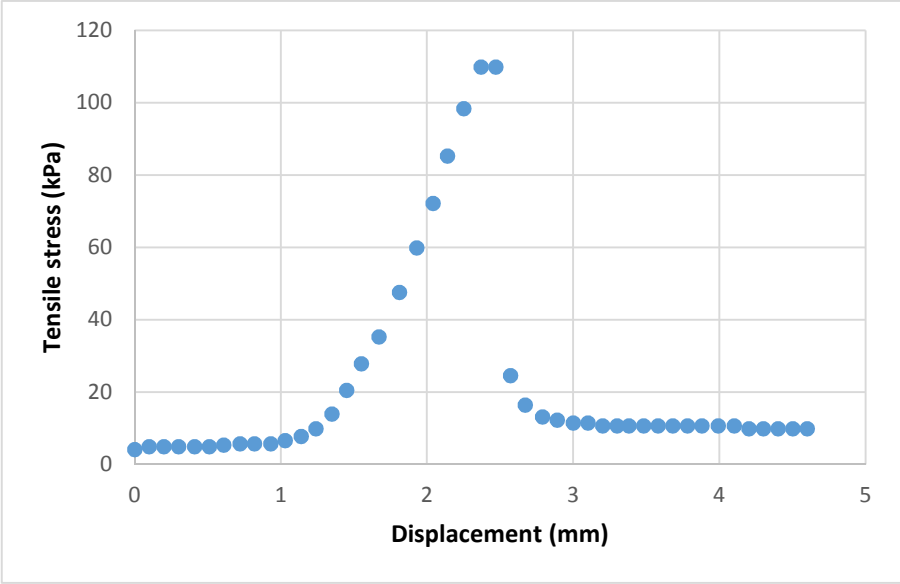
Typical test result is shown in Figure 3, with a very slight changes in the beginning, and then an abrupt changes till a peak that is followed by a sudden decrease. The peak stress value corresponds to the tensile strength of the soil specimen.

Figure 3. Tensile strength versus displacement for test on F3

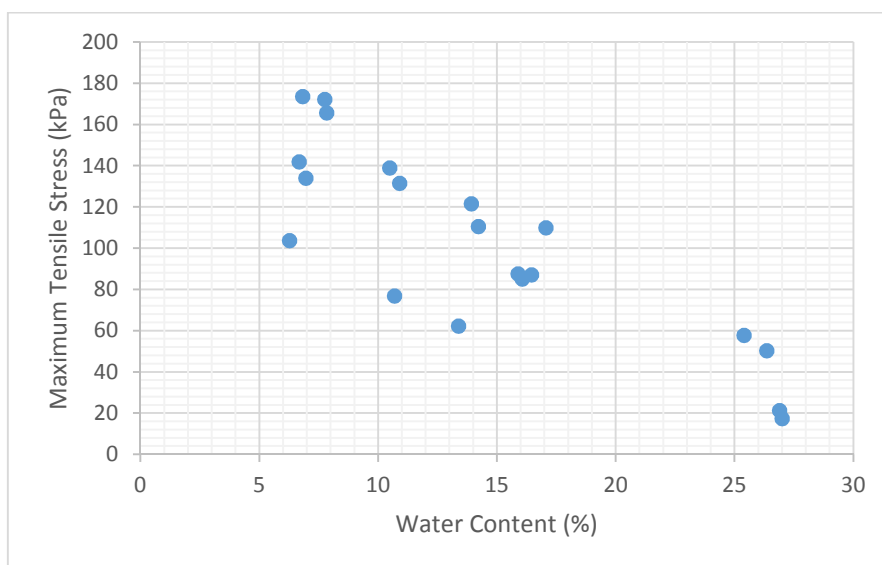
Figure 7. Maximum tensile stress versus water content

Figure 7 depicts the variations of the maximum tensile stress with water content. Despite the data scatter related to the samples' homogeneity, a clear increase of tensile stress with the decrease of water content can be identified, in agreement with results reported in the literature on other soils. This increase is commonly attributed to the effect of soil suction.

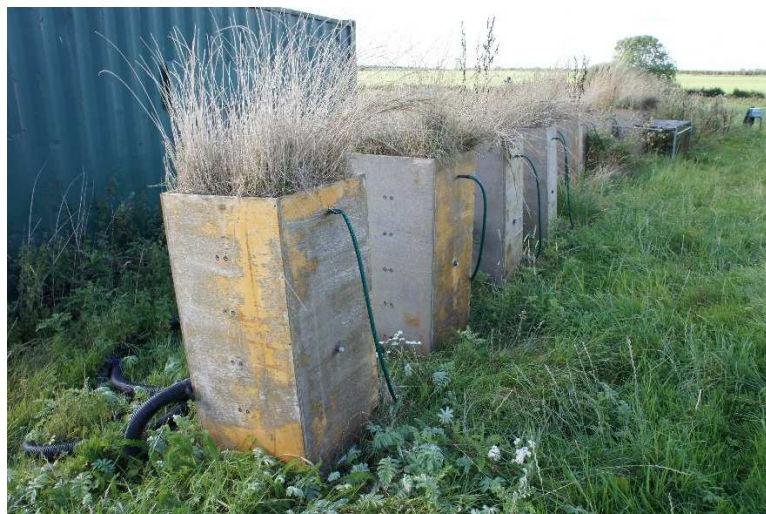
This study can be extended to the vegetation effect. With vegetation, the scenario becomes more complicated because two phenomena occur simultaneously. On the one hand, transpiration from vegetation increases the soil suction, enhancing the soil cracking; and on the other hand, the roots of plants/grass reinforces the soil against cracking. This investigation can be done based on an ongoing study at the site of the experimental embankment, with site lysimeters (see Figure 8).

Figure 8. Site lysimeters with water content measurements and grass roots monitoring, next to the Bionicle experimental embankment
